Pázmány Péter Catholic University Doctoral School of History Doctoral Programme in Archaeology

Closing Systems of the 12th and 13th Century Buildings in the Near East

Submitted by Dania Keyrouz

January 2024

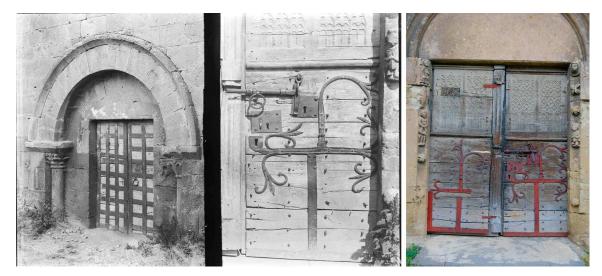
Figure 1: The doors of Notre-Dame de Mailhat church. Left: The cloister door; middle and right: the shutters of the Southern door (POP: La Plateforme Ouverte du Patrimoine, Monuments historiques, 1992).

Another significant example is the Benedictine church of Notre-Dame de Mailhat in Lamontgie (Figure 17). Despite undergoing notable modifications introduced in the 15th and 16th centuries, the original hinges of the lower part of the south side entrance door survived. They have been replaced on more recent wooden leaves, the upper part of which is carved. These hinges are

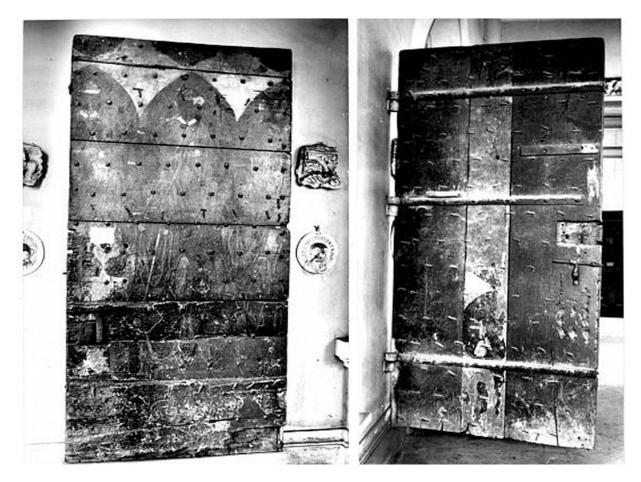
Figure 2: The sacristy door of Saint-Victor-et-Sainte-Couronne Church in Ennezat (POP: La Plateforme Ouverte du Patrimoine, Monuments historiques, 1992).

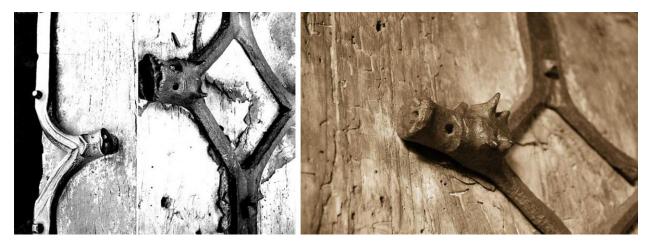
Figure 3: First two pictures from the left: details of hinges of Saint-Julien Basilica in Brioude (Cl. O. D. M. H. 242a, 1942); and right: a detail of the hinges of Saint-Laurent parish church in Auzon (POP: La Plateforme Ouverte du Patrimoine, Monuments historiques, 1992).

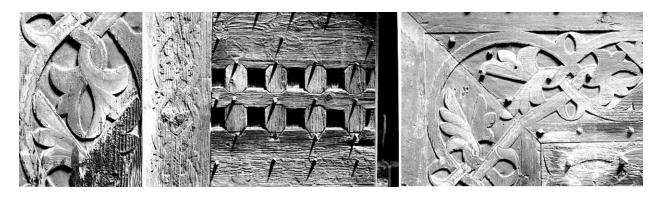
Figure 4: Details of the door of Saint-Gilles Church in Chamalières-sur-Loire (CI. O. D. MH 125711, 1943).

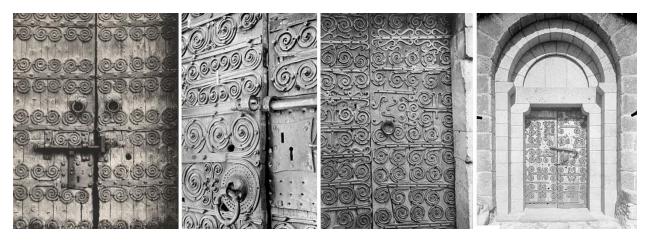
Figure 5: The spiral hinges of the churches in Pyrénées-Orientales. From left to right: Sainte-Marie in Corneilla-de-Conflent, Sainte-Marie in Serralongue, Saint-Fructueux parish church, and Saint-Marie in Coustouges (POP: La Plateforme Ouverte du Patrimoine, Monuments historiques, 1992).

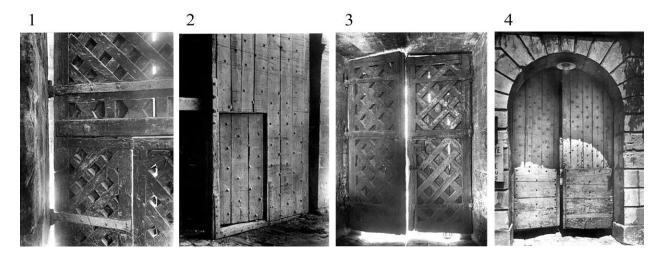
Figure 6: Details of the doors of Blaye citadel in Gironde. Gironde. Hurault, P. Cl.M.H 251824, Cl.M.H 251823, Cl.M.H 251831, and Cl.M.H 251830, 1956.

The final technique for building a gate leaf that involves superimposing wooden boards in opposite directions is known as the "braced" method, which led to multiple variants. This method is considered the simplest and most economical way to install a "strong door".⁸¹ Justin Storck defined the "braced door" as a door without a frame that is composed of boards nailed onto other boards in a diamond pattern.⁸² This diamond arrangement is easier to repair because the short boards could be replaced. This type of door is commonly utilized for citadel entrances due to its thickness, as they are often double or triple the thickness of other door types.⁸³ This observation is exemplified by the example of the royal gate of Blaye citadel in France (Figure 3).

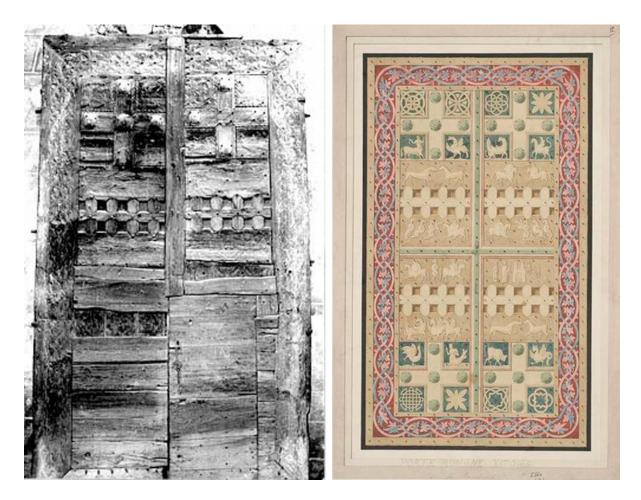
Figure 7: Left: The original leaves of Saint-Gilles Church in Chamalières-sur-Loire (C.Arch. L904, pp 68-69). Right: Restitution of the leaves (A. Normand Aquarelle, s.d., MAP, inv. 5560 (013), MH 08R00138).

period. For example, also in South France, two churches bear carved leaves: Saint-Gilles Church in Chamalières-sur-Loire (Figure 20) and the 11th century priory of Lavoûte-Chilhac. The 12th century original wooden door leaves of Saint-Gilles were previously carved with crosses and floral motifs. They were made of double layered planks joined together with nails, with some of the nail heads taking on a pyramidal shape. The planks of the upper part of the leaves are arranged in two crosses, one on each leaf, and below them are eight smaller crosses. However, the leaves were damaged and pieces were missing at the time they were photographed. Figure 23 shows the described leaf and its reconstruction attempt. The author proposes a restitution of the lower part as a mirror of the upper part, but the few remains of the lower part show that this restitution is inaccurate.¹⁵⁵ Moreover, the door leaf of the sacristy at the priory of Lavoûte-Chilhac is believed to date back to the 11th or 12th century.¹⁵⁶ Similar to the door leaves of the Saint-Gilles Church, it is made of two layers of wooden planks forming a single cross in the upper part of the door (Figure 24). From the middle of the leaf and downwards, the wooden planks are carved with letters and motifs. More carved wooden doors are also seen in Provence-Alpes-Côte d'Azur region, in the churches of Le Bar-sur-Loup commune in Alpes-Maritimes and in Saint-Michel of Salon-de-Provence in Bouches-du-Rhône. Both of them have door leaves built in the first half of the 13th century.157

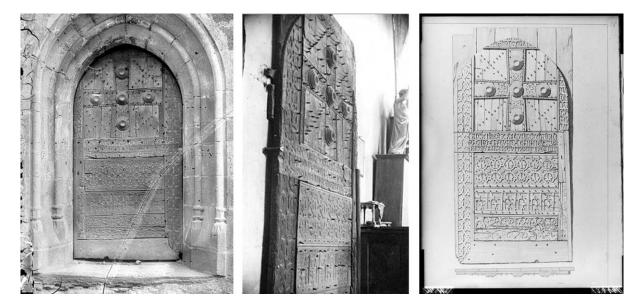
Figure 8: Door leaves of the sacristy of the Priory of Lavoûte-Chilhac (POP: La Plateforme Ouverte du Patrimoine, Monuments historiques, 1992).

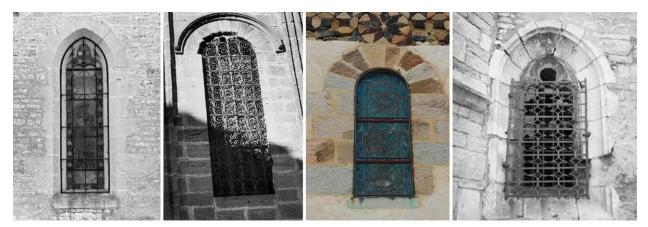
Figure 9: Examples of medieval church windows in France (POP: La Plateforme Ouverte du Patrimoine, Monuments historiques).

Almost all medieval churches captured in the photographs have the same composition of windows. Specifically, a two-layered closing system is present, with the outer frame consisting of vertical and horizontal bars. These are completed on the interior side by stained glass panels which are usually held together by long strips of lead. The whole composition have saddle bars that are fixated in the stone frame to keep glass from blowing into the building. The stained glass windows in medieval churches exhibit a range of shapes and colours, often featuring simple geometric designs as seen in the windows of the Gothic Cathedral of Saint-Étienne in Bourges (Figure 26). They are estimated to date back to 1220.¹⁵⁹ However, not all Gothic churches follow the same pattern as some display intricate and complex illustrations with glass panels, such as the churches of Beaujeau-Saint-Vallier-Pierrejux-et-Quitteur in Haute-Saône and Saint Julien in Chauriat (Figure 25).

In addition to the traditional vertical and horizontal bars, some medieval churches feature a metal grid on the outer frame of the window instead. The design of the grid can vary from simple to very elaborate, as can be seen in the windows of Le Thor Church in Vaucluse and Saint-Gengoux-le-National in Haute-Saône (Figure 25).

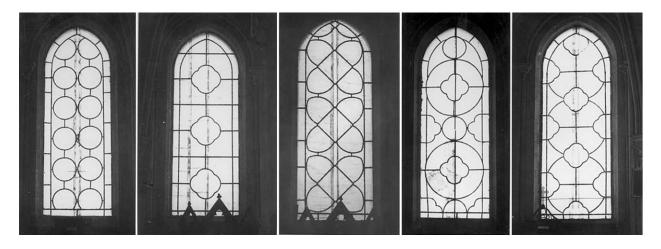
Figure 10: Stained glass windows of Saint-Étienne Cathedral in Bourges, France (Ph. Hurault Cl.M.H, 1945).

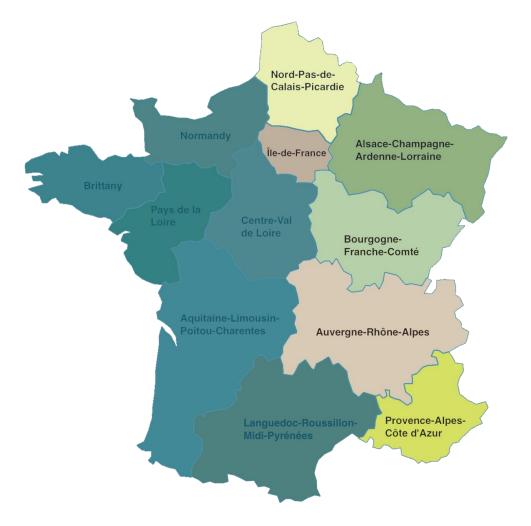
Figure 11: Highlighted regions containing the churches listed by Enlart in Table 4.
